Drainage Report

London

Client:	Location (Street Name):	City/Town/Village London	Cust Job Ref.	Surveyors Name:	Date: 17-04-2020
---------	-------------------------	-----------------------------	---------------	-----------------	---------------------

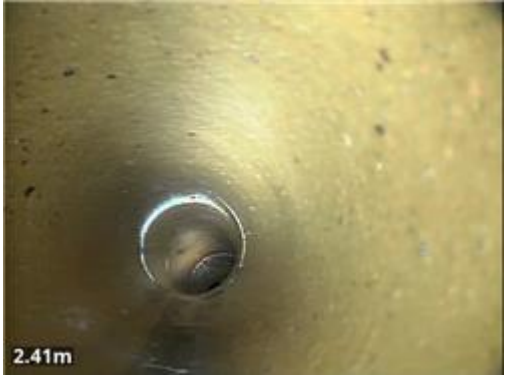
Pos	Video Ref	Code	Description	Image
02.41m	0:00:48	REM	General remark Property Boundary - Beyond this point the drain is owned by and the responsibility of the local water authorities as per the private lateral drain transfer bill 2011	Image Provided - Ref: 0_9

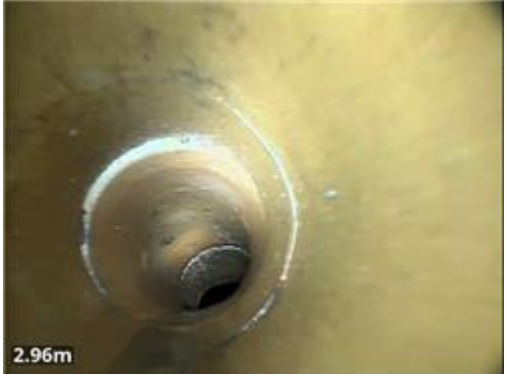
02.96m	0:00:49	FC	Fracture circumferential from 12 o'clock to 06 o'clock - Severity 3	Image Provided - Ref: 0_10

<p>Section: 1 From: MH1 To: Sewer</p>	<p>Recommendation</p> <p>High pressure water jetting scale build up removal to restore the drains full working diameter</p> <p>Installation of a 2.98 meter 100mm resin impregnated drain lining to restore structural integrity to include the excavation and renewal of Gully 1 allowing for direct connection to manhole chamber 1 providing future access and the installation of an uncompromised continuous drain lining.</p>	<p>DRB Grade: B Pipe Size: 100 Material: Vitrified Clay (i.e. all clayware) Use: Combined</p>
<p>Section: 2 From: MH1 To: Grd Fir WC</p>	<p>Recommendation</p> <p>High pressure water jetting scale build up removal to restore the drains full working diameter</p>	<p>DRB Grade: B Pipe Size: 100 Material: Polyvinyl Chloride Use: Combined</p>
<p>Section: 3 From: MH1 Branch 1 To: SVP</p>	<p>Recommendation</p> <p>High pressure water jetting encrustation removal to restore the drains full working diameter</p> <p>Installation of a 1.10 meter 100mm resin impregnated drain lining to restore structural integrity</p>	<p>DRB Grade: B Pipe Size: 100 Material: Cast Iron Use: Combined</p>

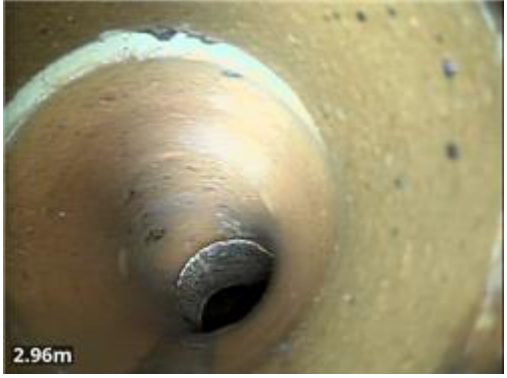
02.97m	0:00:50	JDM	Joint displaced medium - Severity 3	Image Provided - Ref: 0_11

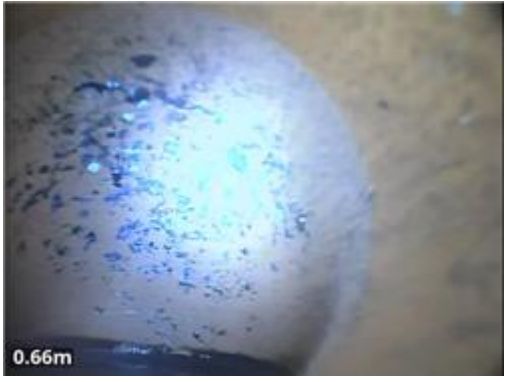
Pos	Video Ref	Code	Description	Image
00.00m		MH	Start node type, manhole MH1 Branch 2	
00.00m	0:00:00	WL	Water level: 0% Height/Diameter	
00.77m		GYF	Finish node type Gully Gully 2	<p>Image Provided - Ref: 3_9999</p>
