Damp & Timber Survey Report
10 Sample Lane, Sampleton, Sampleshire, SA1 2MP

A. Introduction to your Report

Surveyor's Name	Mr Stuart Blackburn CSRT
Date of Inspection	8 December 2015
Date of Report	8 December 2015
Client's Instructions	<p>Your instructions were to carry out a damp and timber inspection to the accessible areas of the property.</p> <p>Unless otherwise stated in our Report, our survey was limited to the areas that you asked us to inspect.</p>
Property Address	10 Sample Lane Sampleton Sampleshire SA1 2MP
Property Status	<p>The property was occupied.</p> <p>Items of furniture and fitted units prevented access in several places. We are not able to comment on the condition of a concealed wall though in some circumstances we may have assumed its condition based on the condition of immediately adjacent sections of wall. Similarly, where floor coverings are present, we cannot comment on the condition of the timbers beneath them, but in some cases we may be able to estimate their condition based on adjacent, accessible timbers.</p>

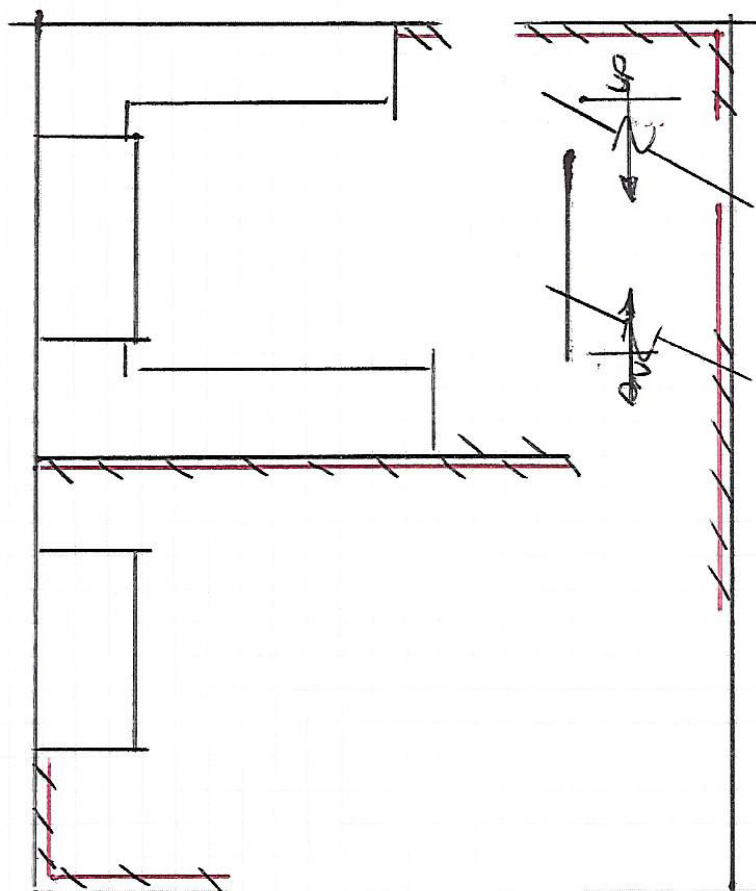
Ground floor

In several areas of the ground floor of the property, our surveyor observed severe damp at low levels, just above skirting boards. It is our surveyor's assessment that this is the result of a rising damp problem. The cause of this appears to be the moisture emanating from the areas below these floors. Readings with a MMS2 Protimeter were taken and indicated high WME Wood Moisture Equivalent (WME) moisture content. Where readings were taken in the skirting boards, a moisture content in excess of 26% was observed. Wood rotting fungi can germinate at a moisture content of 18% and so this presents a cause for concern.

Our surveyor found evidence of salt-contamination requiring specialist replastering on the areas of the wall plaster which are indicated on the Sketch Plan in Section C of this Report.

We recommend the insertion of a chemical damp proof course to the areas indicated on the Sketch Plan. These works will be carried out in accordance with our Specification, which we attach with this report.

To cure the affected areas of salt contamination, the plaster holding the salts needs to be removed up to a height of approximately 900mm from the floor level. This should then be replaced with our specialist salt-retardant rendering system.
